# Using Remote Vision to Navigate Visually Impaired Pedestrians: The Effects of Video Image Resolution on the Performance

Vanja Garaj

School of Engineering and Design, Brunel University

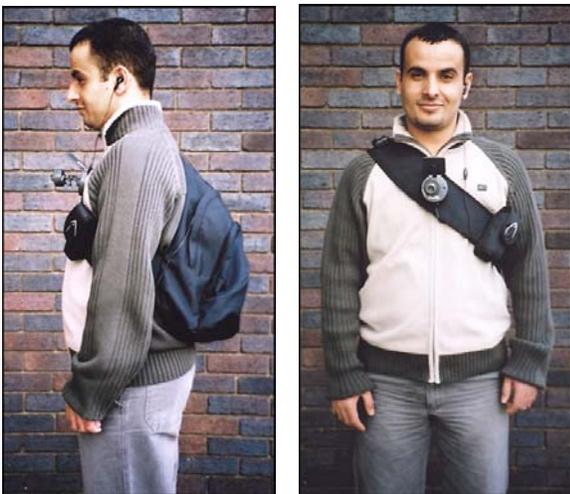
Figure 1. The User's Terminal

The user's terminal is a wearable mobile device that includes a portable video camera, a GPS receiver and an electronic compass (Figure 1). The guide's terminal is organised as a stationary personal computer workstation involving a GIS application and a screen with the capacity to concurrently present the digital map of the user's travel environment contained in the GIS application, the video image recorded by the camera in the user's terminal and the user's heading data from the electronic compass (Figure 2). The video camera built into the user's terminal and the video image display in the guide's terminal form the basis of the system's remote vision facility, whereas the GPS receiver and the electronic compass in the user's terminal, combined with the GIS application and the digital map display in the guide's terminal, comprise the system-integrated positioning and tracking unit.

When the system is in operation, the video camera in the user's terminal (positioned on the user's chest and pointed onwards) continuously records the video image of the immediate environment ahead of the user - covering the area extending vertically from the ground up to above the level of the user's body height and horizontally in multiple body widths. At the same time, the GPS receiver captures the radio signals emitted by the GPS satellites visible to the antenna of the receiver at any given moment in time and, based on the information on the position of the satellites in space encoded in the signals, the processing unit in the user's terminal calculates the location of the receiver, i.e. the location of the user, in the user's travel environment. In addition, the electronic compass establishes the data on the user's heading.

While the video clips were being recorded, the video camera was continuously held in the position that resembles the chest position at which the camera integrated in the user’s terminal of the System for Remote Sighted Guidance of Visually Impaired Pedestrians is located when the terminal is worn by the user (Figure 1). The walking speed during the recording was kept at around 1m/s. The speed<sup>3</sup> was controlled by a speedometer built into the portable pedometer that was carried along.

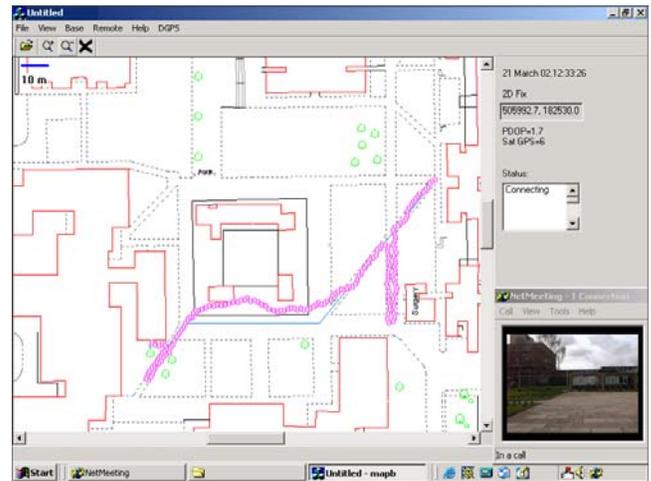
Figure 2. The Screen of the Guide's Terminal

terminal, the location and heading are presented on the screen of the terminal together with the received video image. The process of updating the video image and the location and heading is repeated continuously - for as long as a remote guidance session takes place.

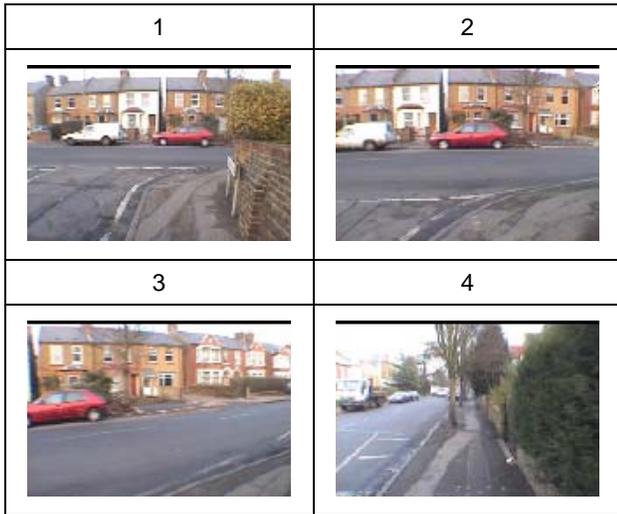
**Figure 3. A sequence of images from one of the study video clips**

The video clips present a range of diverse environmental settings and, as such, a variety of static environmental hazards that can be encountered on everyday journeys through urban environment. Whereas the number of secondary obstacles, tertiary obstacles and the environmental features falling into the Path Information category varies between the clips, in each of the clips there is only one primary obstacle. The primary obstacle always appears in the ending part of the clip and all the clips finish exactly at the point of contact with the obstacle. Figure 3 shows a sequence of image captures from one of the video clips used in the study (VC.7).

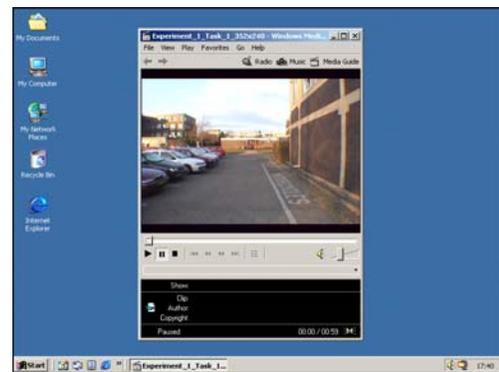
**Figure 4. A study video clip in relation to the resolution of the screen: Version 2 (352x240 pixels)**

The clips were presented on a 17" CRT monitor (VGA) made by Viglen. During the presentation of the clips, the monitor screen was set at the resolution of 800x600 pixels. The screen capture below (Figure 4) shows the relationships between a study video clip (VC.1) in Version 2 video image resolutions and the monitor screen. The clips were run using Windows Media Player. Throughout the engagement in the performance of the study task (the task of the hazards recognition), the study participants were positioned approximately 80cm in front of the monitor.
